Case Study

## Electrostatic Ignition of Toluene Vapors during Vacuuming Truck Operation

### Operation: vacuuming of off-spec toluene from a sump

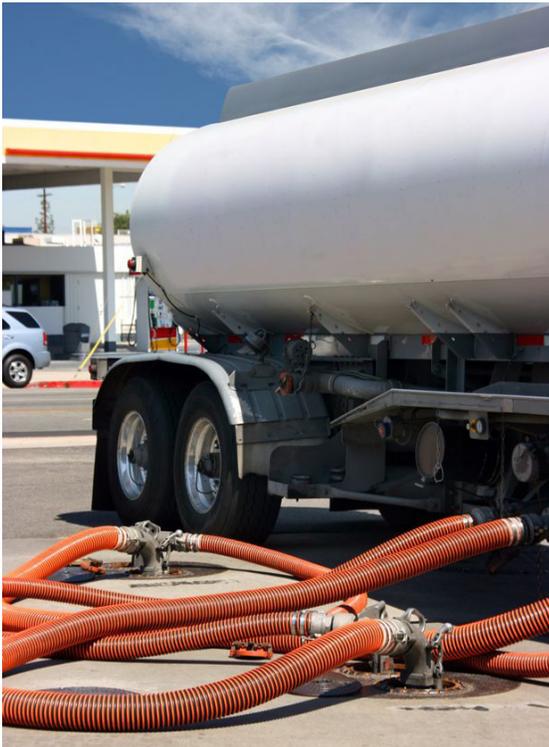
In summary IEC TS 60079-32-1 states that the truck should only be grounded via “designated” grounding points. “Designated” means that the point has been tested and verified as having a direct connection to earth.

The primary function of designated grounding points is to provide grounding protection for electrical circuits, lightning strikes and static electricity. The resistance from the truck to the designated grounding point should not exceed 10 Ohms and should be verified with a truck mounted grounding system or ohmmeter. Metallic systems include electrical circuits inside grounding systems as the static charge should pass directly from the truck to the grounding clamp via copper tracking located on the grounding system’s PCB.

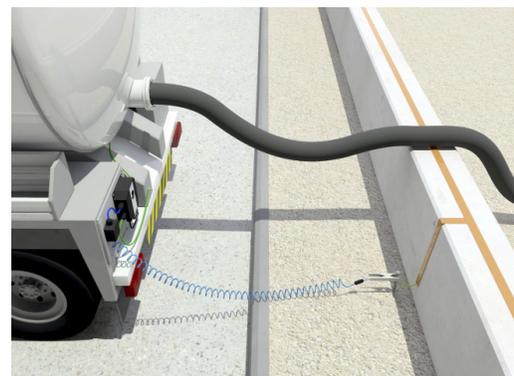
If a truck mounted grounding system had been used by the contractor providing waste removal service at the site in this case study, this fire would have been avoided. There are several benefits of using a truck mounted grounding system. One such example is the Earth-Rite® MGV.

- The Earth-Rite MGV automatically verifies if the truck is connected to a ground source that is connected to the mass of the earth.
- It will monitor the resistance between the verified ground source and the truck so that if exceeds 10 Ohms the green LED indicators will switch from pulsing green to red.
- Internal dry contacts can be utilized to shut down the movement of liquid or powder if the Earth-Rite MGV detects that ground connection is not present.
- Site electricians do not need to perform a one-time check with a meter. The Earth-Rite MGV will not only perform this check automatically for the driver, it will continue to monitor the connection for the duration of the transfer operation.
