**Case Study**

## **Spark from Isolated Hose Ignites Combustible Powder Atmosphere**

*Source: "Static Hazards Using Flexible Intermediate Bulk Containers for Powder Handling",  
Laurence G. Britton, (1993)*

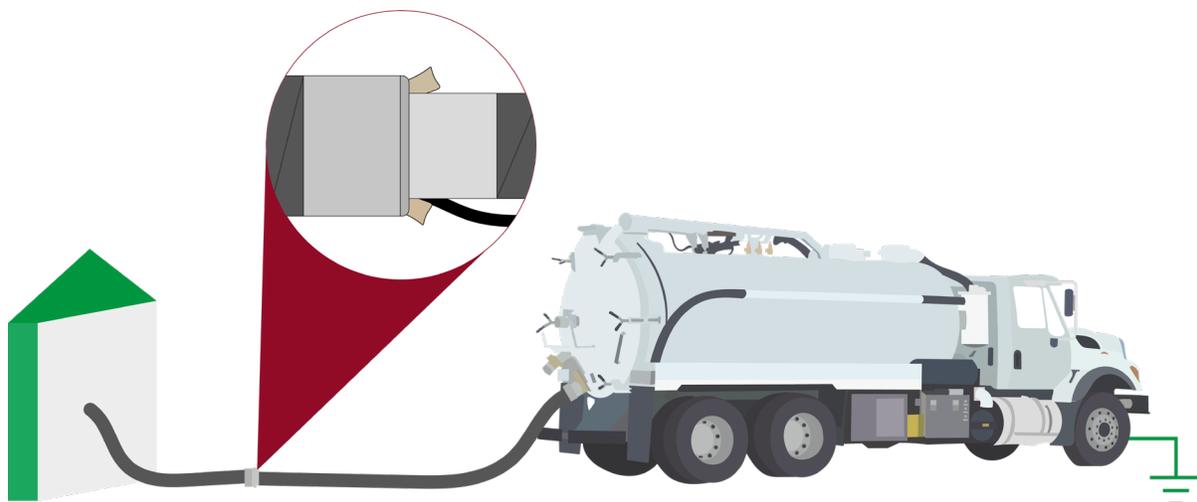
One issue that was encountered, however, was that the plant hose that was used to complete the distance between the truck's hoses and the entry to the plant's pneumatic system was wider in diameter to the truck's hoses. This meant that a sealed connection between the hoses could not be made. Instead of electrically isolating the plant hose from the truck's hose, potentially impeding the transfer of electrostatic charges from the plant hose to ground via the grounded truck. The other end of the hose was assumed to have been resting on the concrete floor inside the plant. The other issue was that the density of the air-powder phase coming from the truck was above the minimum explosive concentration of the aluminium powder.

The isolated hose was estimated to have a capacitance of 30 pico-farads and a modest value for the streaming current generated by the transfer of the powder aluminium was estimated to be in the region of 10 micro-amperes. The resistance to ground of the isolated hose's flange, resting on the concrete floor, fell into a range of between  $10^{10}$  ohms and  $10^9$  ohms. The voltage ( $V=RI$ ) on the isolated hose, based on the upper and lower limits of resistance, was estimated to fall between 100 kilo-volts and 10 kilo-volts.

The energy,  $W$ , from a spark discharge based on the capacitance and voltage on the isolated hose ( $W = 0.5 CV^2$ ), would have been in the range of 150 milli-joules to 1.5 milli-joules. Hence a spark from the isolated hose would have been likely to have had the capability to ignite an explosible concentration of the aluminium dust.

As the operators needed to improvise through this non-standard scenario, it is all too easy to criticise the lack of static grounding precautions that were adhered to. Electrostatic hazards are not an easy concept to grasp, especially when improvisation is required. One standard operating procedure that may have re-enforced good practice was to have the truck driver trained to test the electrical continuity of the hoses back to the grounded truck. This would enable the driver to ensure a transfer could not take place unless all components in contact with the charged powder were grounded. One means of achieving this is for the driver to carry out a resistance check with an ATEX/HAZLOC certified ohmmeter (or multi-meter) to ensure the combined resistance of the hoses does not exceed unsafe levels.

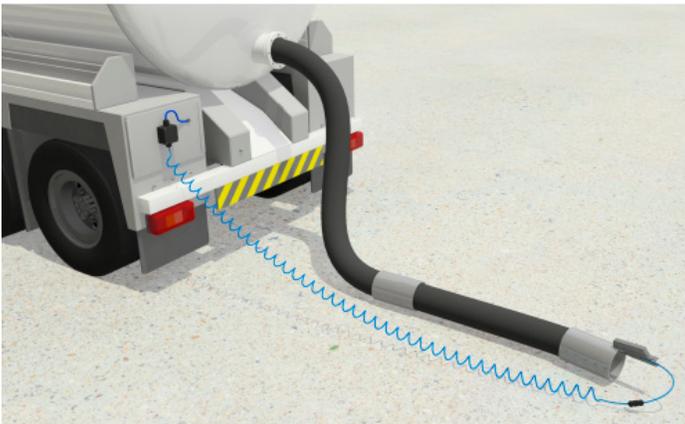
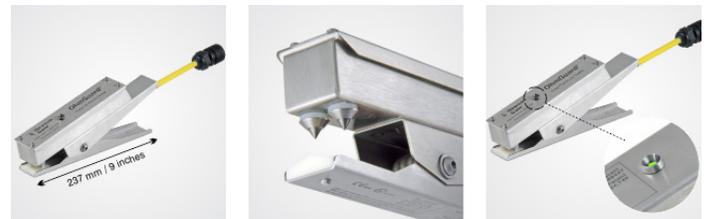
If there are concerns about the correct use of the meter an even simpler method is to utilize a device like an ATEX/HAZLOC certified OhmGuard® tester which provides the driver/operator with a visual indication of whether or not the hoses assembled together exceed safe resistance levels. By simply attaching one end of the OhmGuard to the truck and the other end, which houses the LED indicator, to the end of the interconnected hoses, the tester will automatically determine if the resistance through the hoses is higher than recommended levels. Following a “GO/NO GO” principle of operation, the pulsing green LED indicator visually confirms that the resistance of the interconnected hoses is low enough to dissipate electrostatic charge from the hose, preventing ignitable sparks being discharged into combustible atmospheres.
