Case Study

Risk of Electrostatic Ignition during FIBC Discharging Operations

Source: "Static Hazards Using Flexible Intermediate Bulk Containers for Powder Handling", Laurence G. Britton, (1993)

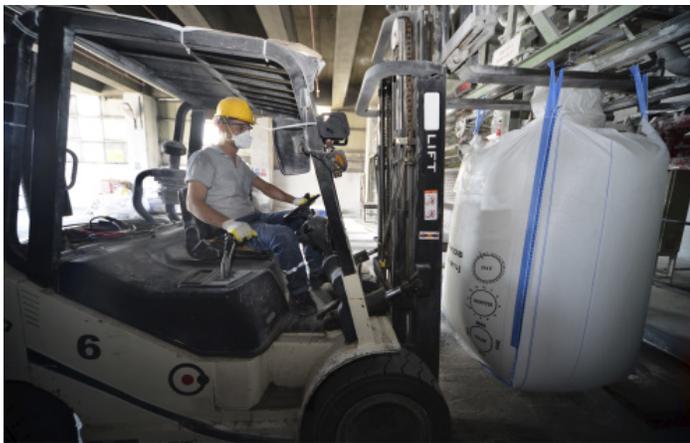
Flexible Intermediate Bulk Containers (FIBCs) have long been considered a great innovation in the transportation of dry flowable material since their introduction in the sixties. Commonly referred to as a “bulk bag”, “big bag” or “tote”, FIBCs have a body made of flexible woven material, typically the high strength thermoplastic, polypropylene, along with a linear insert. FIBCs are efficient, and transportation of dry bulk goods such as sand, fertilisers, plastic granules, seeds, resin and powder coatings, to name a few, can be unloaded at a fast rate, with anywhere between 300 – 500kg typically in 30 seconds or less. Used in agricultural, chemical, food and pharmaceutical industries, FIBCs have proven to be simple to use, cost-effective and strong, and are more convenient than rigid IBCs for powder transfers because they can be collapsed after use and stored away. However, the use of FIBCs are not without their risks and when filling and emptying FIBCs in hazardous areas, electrostatic charge can accumulate on both the contents (product) and the fabric of the material itself. It is common under these circumstances for the rates at which static electricity charges are generated to exceed the rates at which the charges can relax, allowing the accumulation of a static electric charge to develop within the process.

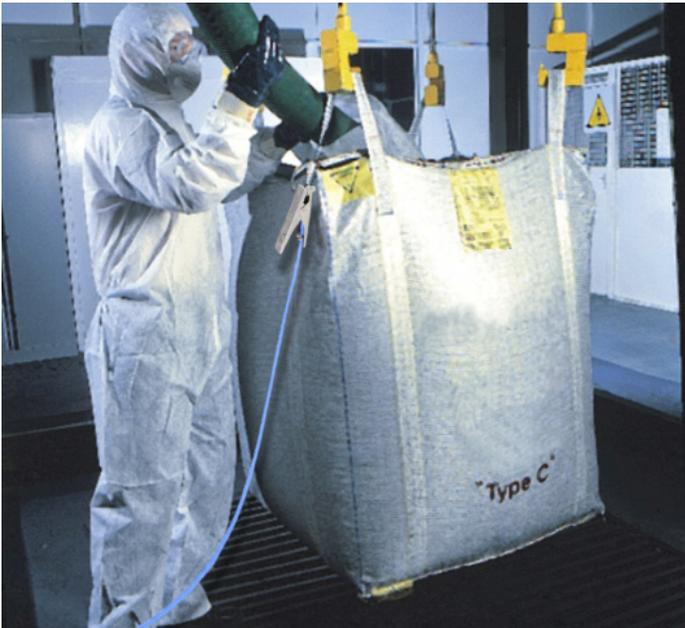
Newson Gale's Earth-Rite® FIBC system validates and monitors the resistance of Type C bags ensuring that conductive elements of the bag are capable of dissipating charges in compliance with the necessary guidelines. Type C bags are designed to dissipate static electricity through static dissipative threads that are interwoven through the bags material. Grounding tabs located on the bags are points where grounding systems can be connected to ensure static electricity does not accumulate on the bag. Once the connection of two grounding clamps has been made onto the grounding tabs, the FIBC system will identify if the bag is operating in accordance with the relevant standard. This is achieved by sending an intrinsically safe signal through the bag. The system verifies the grounding of the bag by ensuring the signal returns via a verified true earth ground (static ground NOT verified by the FIBC). Should any charge have accumulated on the bag, it will leave via the static dissipative threads to the verified ground.

The static dissipative loop system check continuously monitors the resistance of the bag so that if it rises above NFPA 77 - 1×10^7 Ohms or IEC 61340-4-4 - 1×10^8 Ohms, a red LED on the remote indicator station illuminates to tell the operator the system has gone non permissive.

Additional benefits of grounding systems over introductory level clamps and cables is that the movement of product can be controlled through output contacts interlocked with the process; material cannot flow without the permission of the operator.

Simply put, a Newson Gale Earth-Rite FIBC system will have a red LED when:

- 1. The system is not in use**
- 2. The grounding is compromised (exceeds 1×10^7 Ohms or 1×10^8 Ohms)**
- 3. The Type C bag's construction does not comply with the relevant standards**
