Case Study

Risk of Electrostatic Ignition during Storage Tank Cleaning Operations

Source: "Safety Alert: Explosion in tank during HP activities, SIR, (2018)".

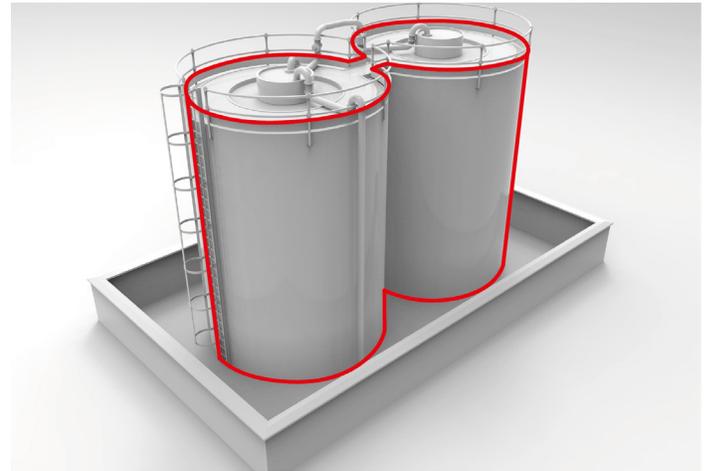
Fig. 1 – Storage tanks within close proximity of each other, means fires can viciously propagate through a tank farm if an incident is to occur.

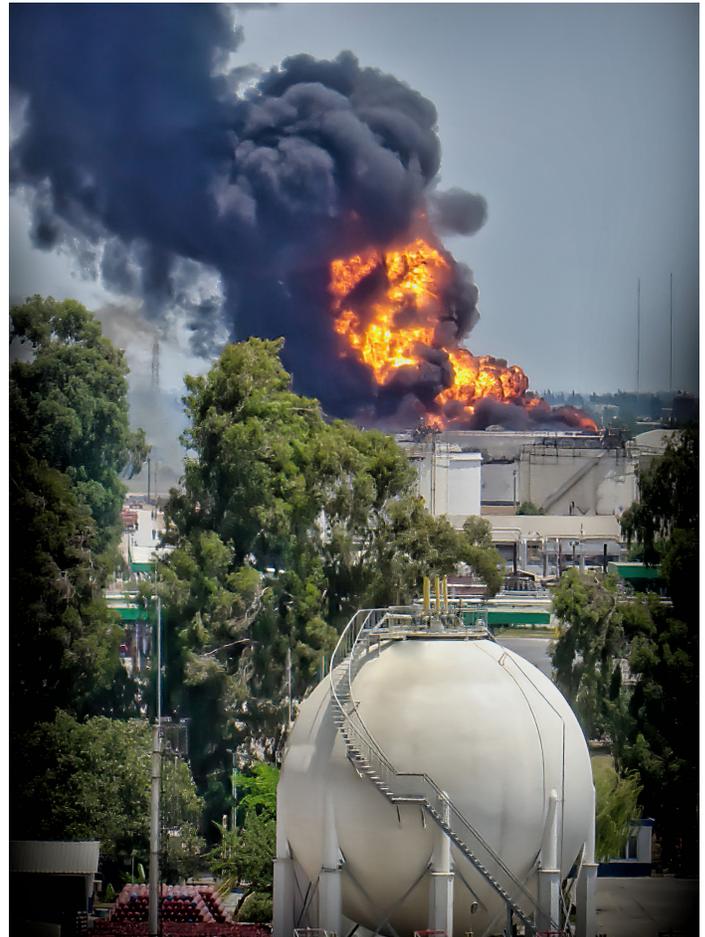
Year	1960-1969	1970-1979	1980-1989	1990-1999	2000-2003	Total
Lightning	4	10	19	37	10	80
Maintenance / hot work	1	5	9	12	5	32
Operational error	1	5	6	8	9	29
Equipment failure	3	1	5	7	3	19
Sabotage	2	5	2	6	3	18
Crack / rupture	0	3	3	3	8	17
Leaks and line rupture	0	3	2	5	5	15
Static electricity	2	1	2	2	5	12
Open flame	1	0	4	2	1	8
Nature disaster	1	2	1	1	2	7
Runaway reaction	2	1	0	2	0	5
Total	17	36	53	85	51	242

Fig. 2 – A Study of Storage Tank Accidents. Based on 242 storage tank accidents in industrial facilities over the last 40 years. Source: “Journal of Loss Prevention in the Process Industries”, James I. Chang, Cheng-Chung Lin, (2005).

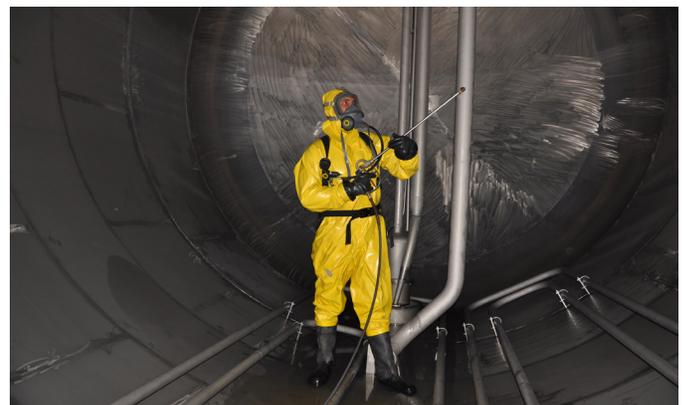
Vapor was generated by the hose held by the operator used to clean the surface of the tank where petroleum residue acted as fuel. If an ungrounded conductor (such as a hose) is lowered into the charged mist, it becomes charged to a voltage which may be high enough for an incendive spark to jump to some part of the tank structure. If a hose with the wrong electrical resistance is selected there is potential for static sparks that could interact with the mist. Charged mist is often present for the duration of the cleaning process and can take several hours to fully relax. The properties of the material itself are fundamental to understanding both charge generation and relaxation. The lower the conductivity, the greater the relaxation time.

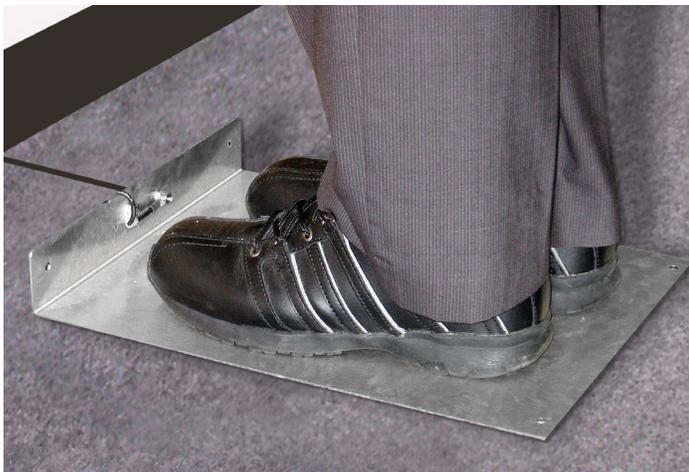
Closer examination of the equipment has to be considered, as well as the operator's path to earth. Through their own movement people can generate large amounts of static charge if they are not grounded. Over 30,000 volts can be carried by people who are completely unaware that they themselves are the potential source of an electrostatic spark discharge that could ignite a flammable atmosphere. The hose operator could have already been carrying enough charge as he entered the vicinity of the tank, however conclusive measures should be implemented to ensure that the condition and resistance of footwear to demonstrate static is capable of dissipating through shoes to ground is ensured. Static dissipative footwear is designed to reduce hazards that may occur due to personnel having excessively high resistance to ground. Regular testing of static dissipative footwear is strongly recommended to ensure the static dissipative properties of the shoes do not change during the duration of their use. The provision of footwear to plant personnel only reduces the risk if properly maintained, and this cannot be detected by visual inspection of the shoes alone. It should therefore be a fundamental requirement of organisations that have employees operating in flammable and combustible hazardous environments to ensure that the product (footwear) is capable of fulfilling its designed function of dissipating electrostatic charges.

Stopping charge accumulation on plant personnel is trouble-free and dependent on both wearing the correct footwear and ability to test the properties of the footwear before entering a hazardous area. Prior to commencing with the tank cleaning operation an electrical resistance test would have been recommended.

The Sole-Mate™ II tester from Newson Gale provides a time efficient and cost effective method of ensuring personnel operating in hazardous areas are wearing static dissipative shoes that are capable of limiting electrostatic charge accumulation on their bodies. The system tests the condition and measures the resistance of footwear to ensure static is capable of dissipating from personnel through their shoes to ground.

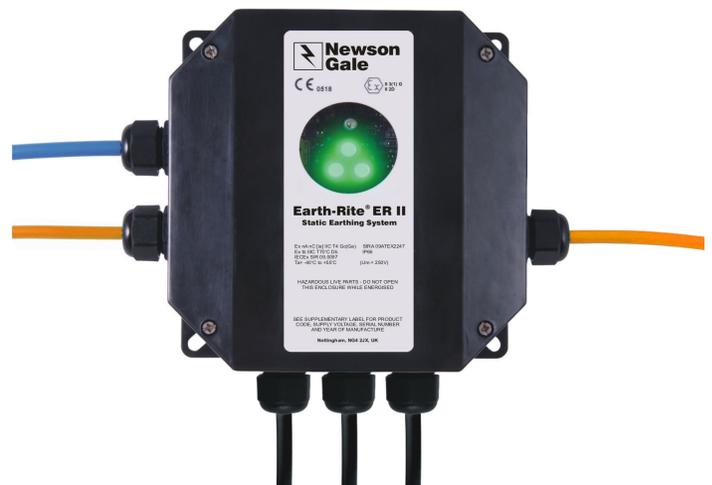
The Earth-Rite® PLUS™ grounding system from Newson Gale combines a simple visual GO/NO GO via a traffic light model (red/green) of indication with interlock control capability. Interlocking with the process is the most effective means of controlling the risks of ignition caused by static electricity during operations. Conductive objects like storage tanks, skids, IBCs and rail cars can accumulate hazardous levels of electrostatic charge that could discharge static sparks with energies far in excess of a vast range of combustible gases, liquids or vapors. The ignition of combustible atmospheres by static electricity can be mitigated by ensuring that such objects are grounded, and the Earth-Rite PLUS system continuously monitors the connection to ground ensuring static is dissipated safely throughout the operation. If the connection to ground is broken during the operation then the red negativity ground connection LED will show and the interlock contacts will open. The Earth-Rite PLUS system demonstrates the full range of ATEX and IECEx certification for all gas and liquid groups. It also ensures there is a 10 Ohms or less connection between the tank and the product transfer system.
